DEPARTMENT OF NATURAL RESOURCES  
DIVISION OF OIL, GAS AND MINING

RE: Site Inspections; International Uranium; Hecla Shaft, La Sal-Snowball, Pandora, and Redd Block IV Projects; M/037/043, M/037/026, M/037/012, M/037/046; San Juan County, Utah

Date of Inspection: May 1, 2002  
Time of Inspection: about 1:00 to 3:00 p.m.  
Conditions: Mostly clear, 50's, windy  
Participants: Doug Jensen and Paul Baker, DOGM

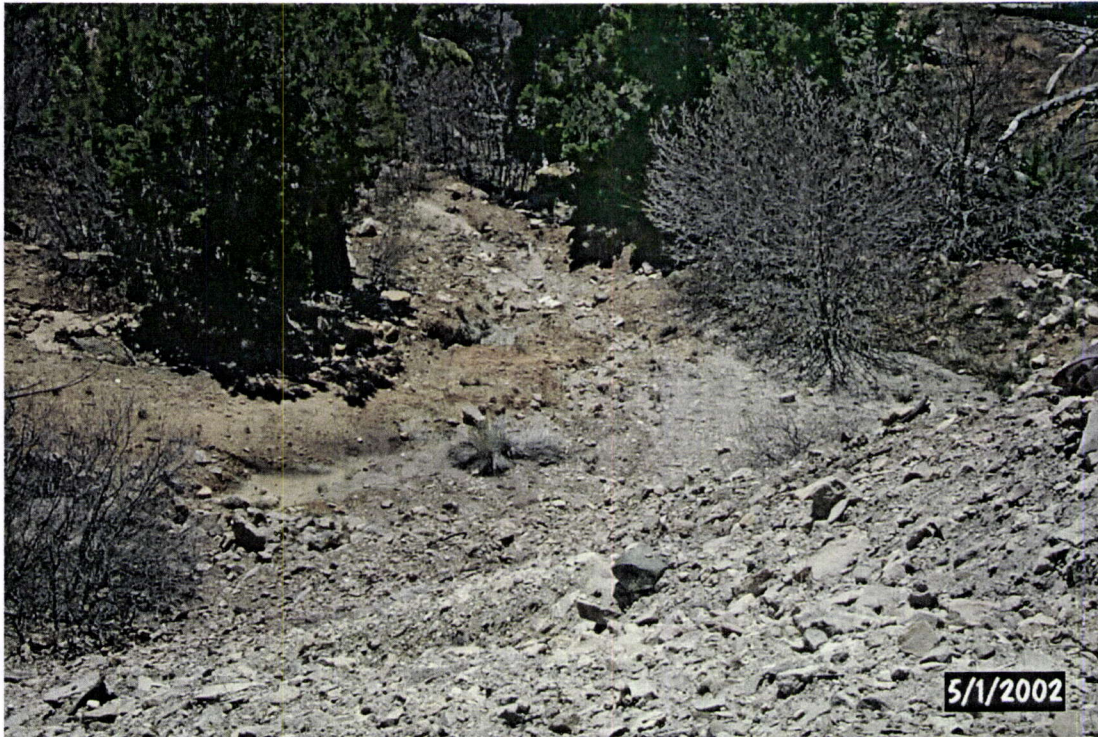
Permit M/037/026 includes both the La Sal and Snowball sites and the Beaver Shaft. At the Snowball site, there has been some erosion from the waste piles (Photo 1), and it appears some of this material has gotten into the drainage (Photo 2). Photo 3 shows some buildings at the Snowball Mine.

Photo 2. Sediment below the waste pile at the Snowball Mine.

The operator should install a silt fence or straw bales in the drainage below the Snowball waste pile to reduce the amount of material getting into the drainage. Otherwise, we have no other long-term maintenance suggestions.

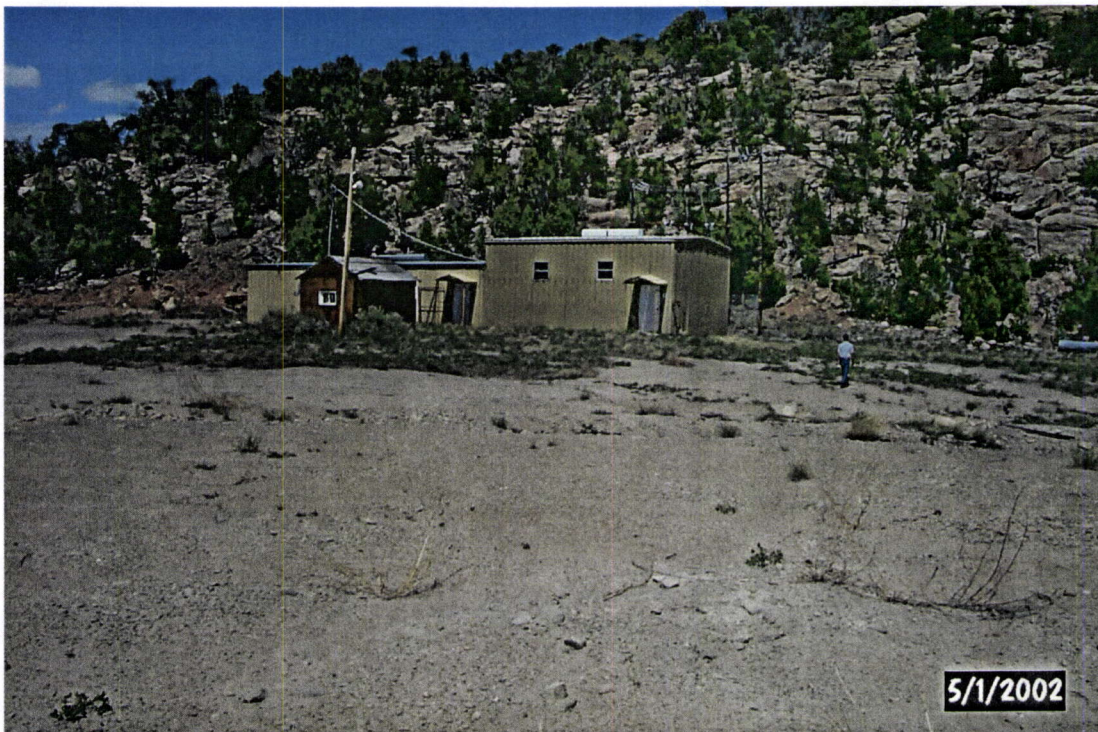
Photo 3. Buildings at the Snowball Mine.

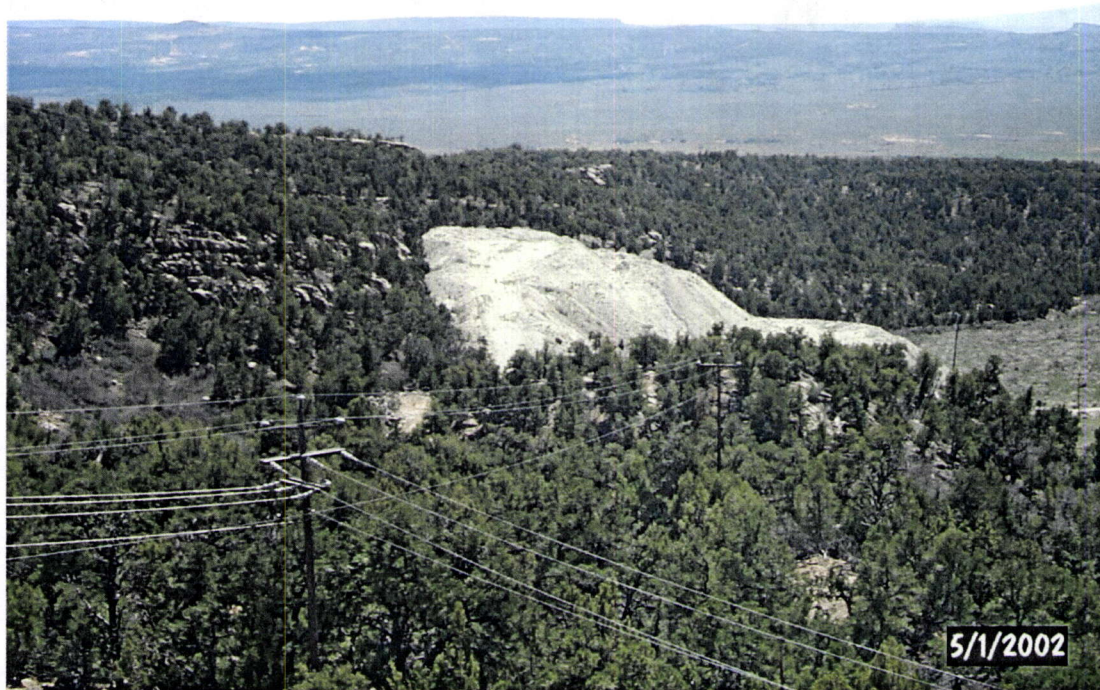
The Snowball and Pandora Mines are both in a canyon, and there would be limited space available to regrade the waste piles although there is some (Photo 4). In places where the waste was stable, there were perennial grasses, sweet clover, small burnett, and other forbs. This indicates the material has some capability of supporting vegetation if it is stable enough for the vegetation to become established. At the site east of the Beaver Shaft (Photo 5), there had been some cattle, and there was also quite a bit of vegetation establishment. It appeared from this that manure would help vegetation establishment on the waste if the waste is used as a growth medium.

Photo 4. Pandora Mine viewed from the Snowball Mine.

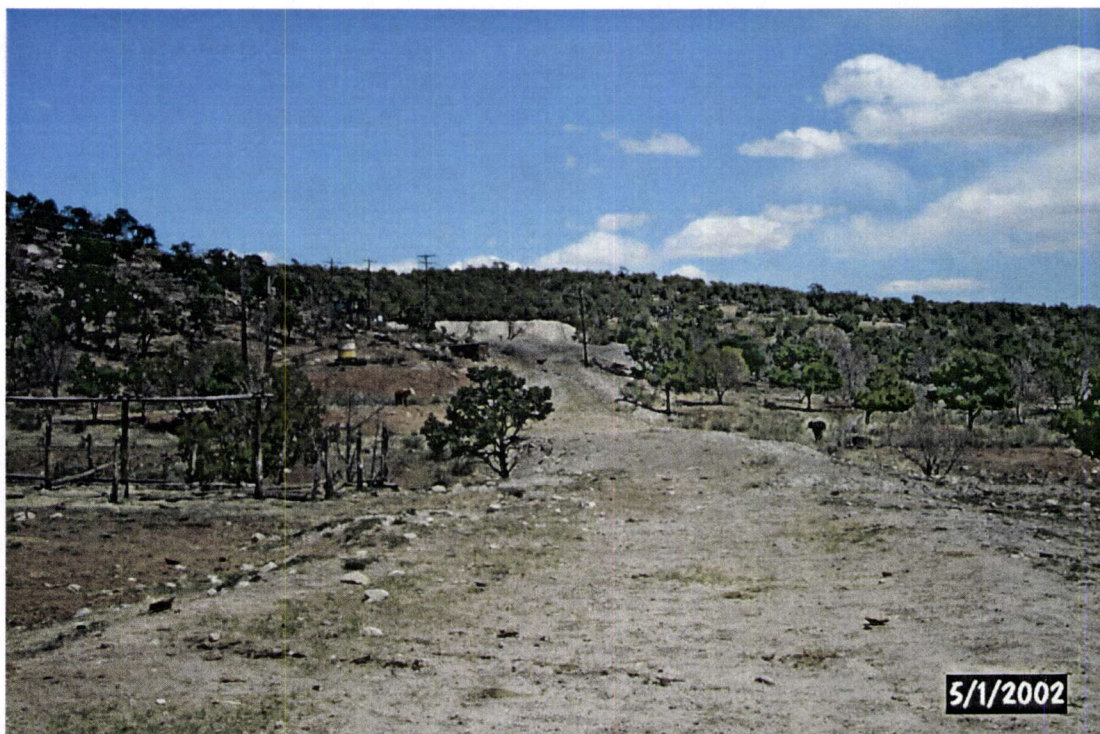
The Beaver Shaft is just north of the town of La Sal, and the headframe is easily visible from the town. There is one road leading north from the town. Take this road then turn west where it comes to a T. There is additional disturbance to the east of the T, and the entire road up from La Sal is included in the disturbed area.

Photo 5. Disturbed area east of the Beaver Shaft.
